Restoration of the historical monument: Al Waha Al Hamra Hotel for its utilisation

Keywords: Historical buildings, rehabilitation, Al Waha Al Hamra Hotel, intervention assessment.

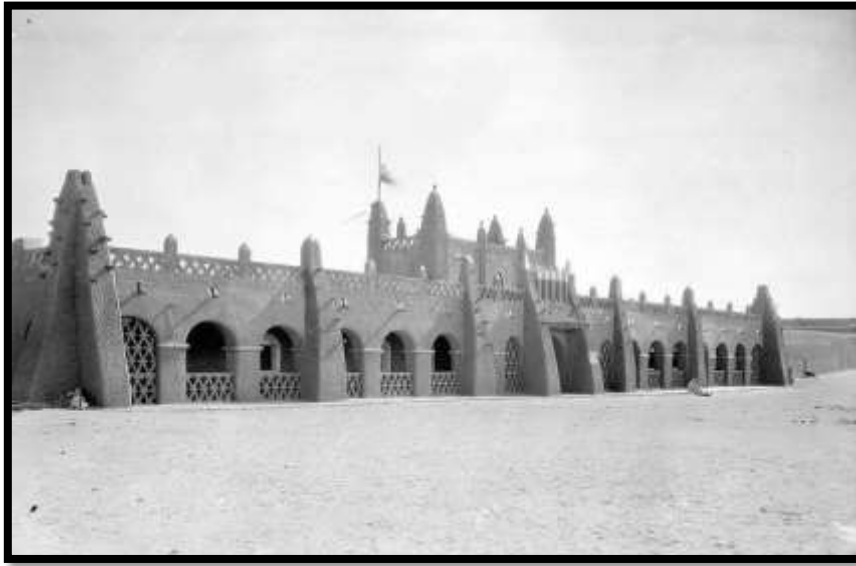
This historic building was constructed as a military supply centre in Timimoun between 1912 and 1917 by the colonial expedition under the direction of French military engineering expert Captain François Atenor. This building clearly facilitated air navigation at the time, as evidenced by the initial plans, which allowed for the appearance of a cross representing the four main axes.

Figure 2: Picture of the building with its original name: Military Supply Centre of Timimoun.

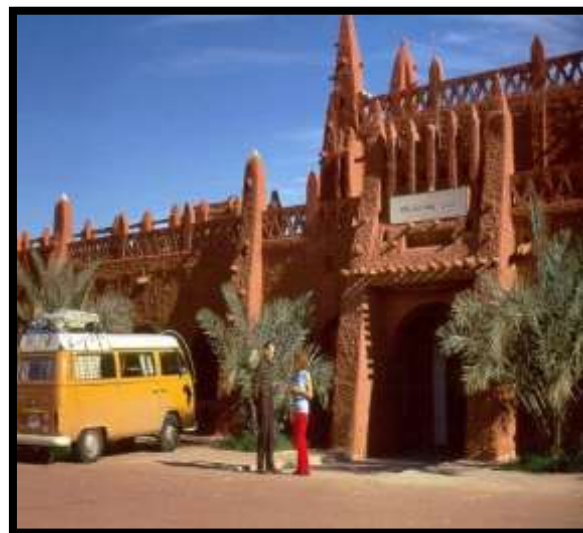
Figure 3: Picture of the building with its second name: Transatlantic Hotel.

On 11 July 1925, the Transatlantic Company acquired the building on a perpetual lease, making it one of 44 hotels in Algeria, Morocco and Tunisia owned by the North African Travel and Hotel Company at the height of its prosperity in 1928. It was then called the “Transatlantic Hotel of Timimoun”.

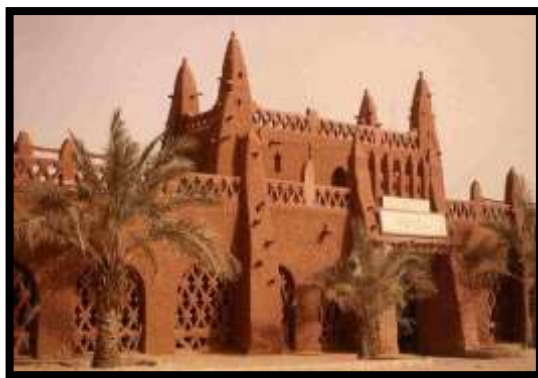
Figure 4: Picture of the building with its third name: Al Waha Al Hamra Hotel

The inauguration of this establishment coincided with the New Year's celebrations of 1926, attended by prominent figures of the time, including André Citroën and the Grand Duchess of Luxembourg⁷. In 1965, the Municipality of Timimoun took over the management of the hotel and renamed it Al Waha Al Hamra, in reference to its architectural style, characterised by the red colour derived from the clay, the main building material in Gourara.

The doors of this building were closed between approximately 1996 and 2001 for restoration, after which it was transformed into the Cultural Radiance Centre of Timimoun, affiliated to the Directorate of Culture of Adrar Province.

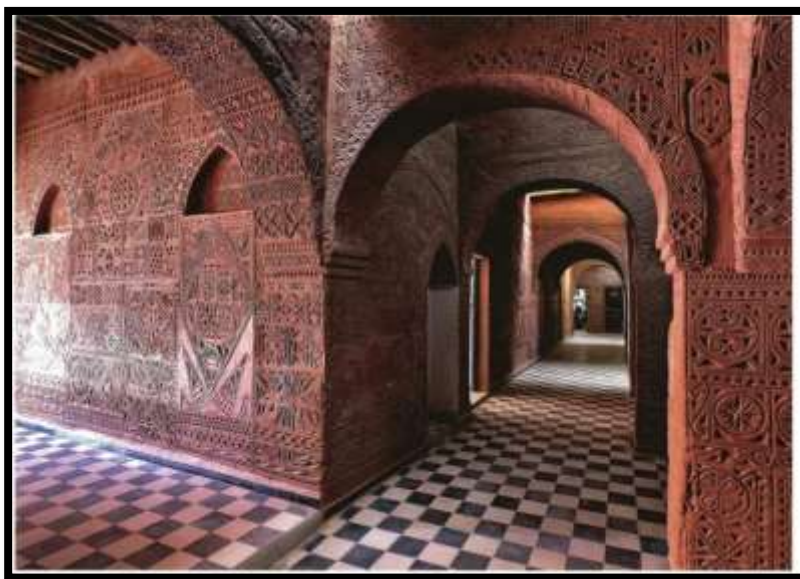
The walls of these corridors, as well as the arches of the hall, are artistically decorated with geometric patterns of symbolic Berber-Islamic significance. The authenticity of this decoration, represented by clay engravings, dates from around the 12th century AD, as shown by the oldest mosque found in Timimoun. It is clear that the French administration employed skilled local craftsmen to decorate the walls of this hotel, in particular a figure called Aba Salim Amirouch.

Figure 6: Image showing local decoration inside the historic building, Al Waha Al Hamra Hotel, Timimoun

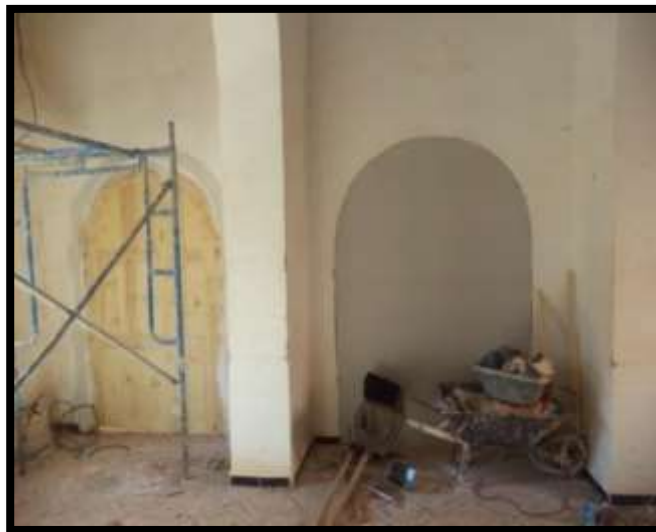
The spaces in the corridors and in the northern main hall were left open without partitioning in order to preserve the unique local decorative murals that make this building an artistic masterpiece.

Figure 11: Image showing the position of the arches after the intervention

The adjacent arch was closed off with plastic sheeting, which served as a shelf for archive boxes. A door was installed for the following arch and the doors were repainted a dark green, while the walls were painted with water-based vinyl paint after the electrical wiring was reinstalled inside the walls.

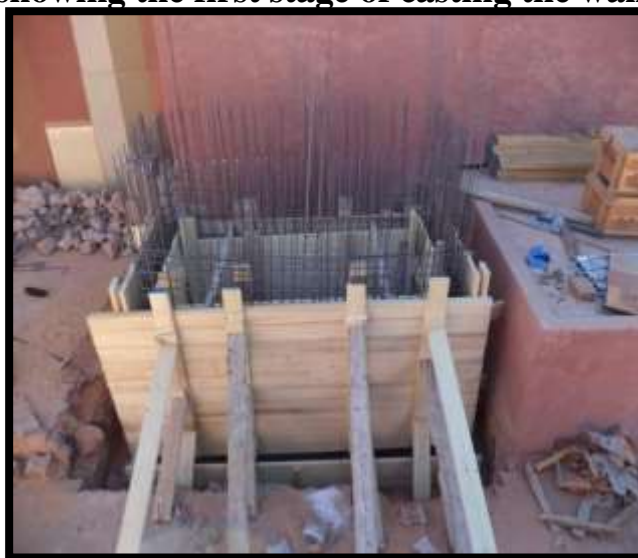
In the eastern part of the building, a water tank of approximately 8 m² was created. Excavation was carried out to a depth of 1.5m, followed by the pouring of a layer of concrete. A steel grid was then installed to define the dimensions of the tank, onto which a mixture of Portland cement with high salt resistance, gravel, sand and hydrophilic liquid for concrete was applied to make the concrete waterproof, all of which was done after setting a formwork (coffrage).

Figure 12: Picture showing the first stage of casting the wall of the water tank.

Once the wall had dried from this first layer, a second stage involved placing a layer of plastic (sikawaterbars) at the bottom of the tank. This was followed by a layer of steel bars, framed with wooden planks, and a viscous mixture of cement, sand and a small amount of gravel. This layer is essential to fill the cavities that penetrate the first layer, before a layer of plaster made only of cement and sand is applied.

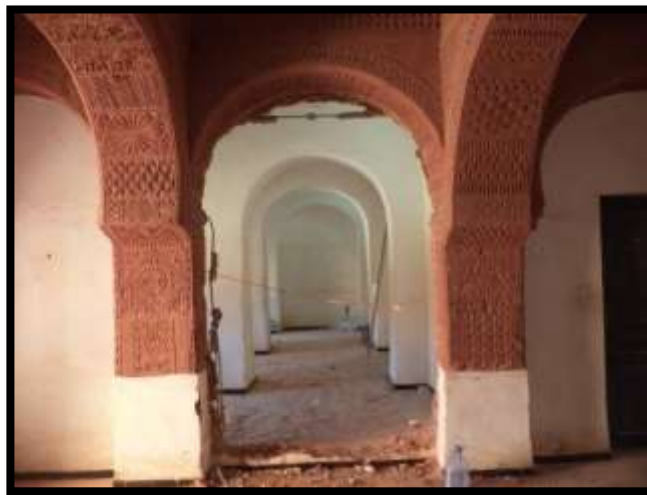
The efforts of the study office responsible for the rehabilitation project of Al Waha Al Hamra Hotel to create additional offices in line with its new function led to the idea of implementing an internal extension in the north-eastern part of the lobby. The main objective was to increase the usable area by taking advantage of the extension of the arches in this rehabilitation context to create new internal levels. The lobby has a U-shape, with three bays formed by three arches intersecting two other bays formed by four arches. To the right of the corridor entrance, an internal extension was created by removing the wall at the level of the two arches.

Figure 13: Images showing the state of the wall removal.

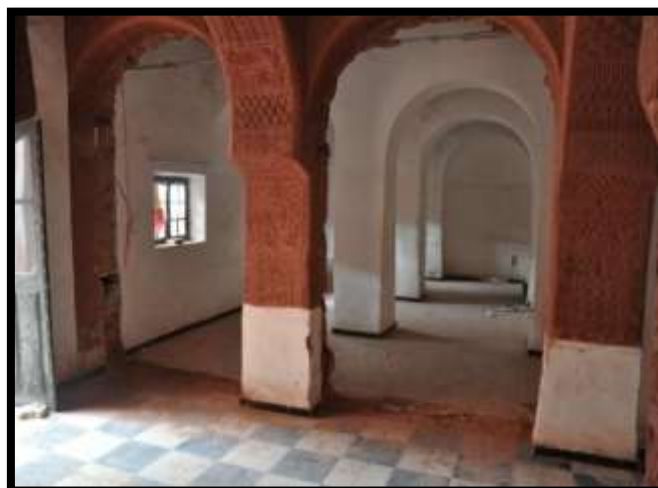
Figure 14: Picture showing the situation after the removal of the wall.

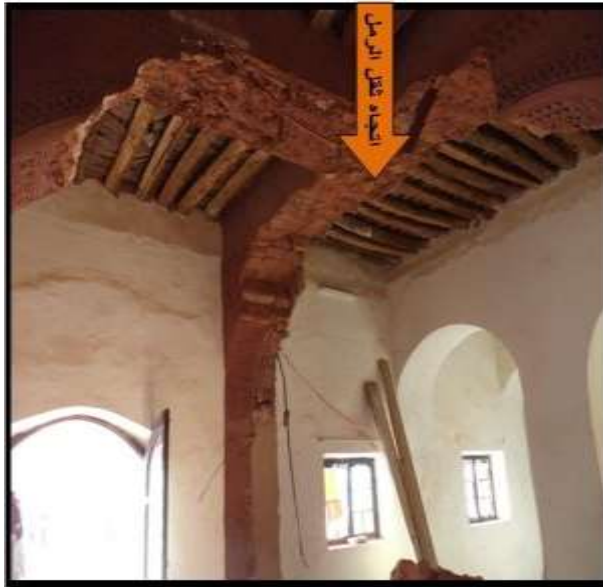
Following this intervention, the supporting structure for the three arches was compromised due to the weight it carried and the capillary transfer of moisture within it, as it was not supported by a foundation in the ground.

Figure 15: Image showing the collapse of the support for the three arches due to the removal of the wall.

The restoration was carried out by re-excavating the foundation of the support to a depth of 80 cm and rebuilding it with stone and cement. The body of the column was then rebuilt with adobe bricks, and the vaults were restored to their original dimensions, continuing the construction with bricks on the iron frames attached to the column, up to

the ceiling. At present, the restoration process has been temporarily halted for administrative reasons.

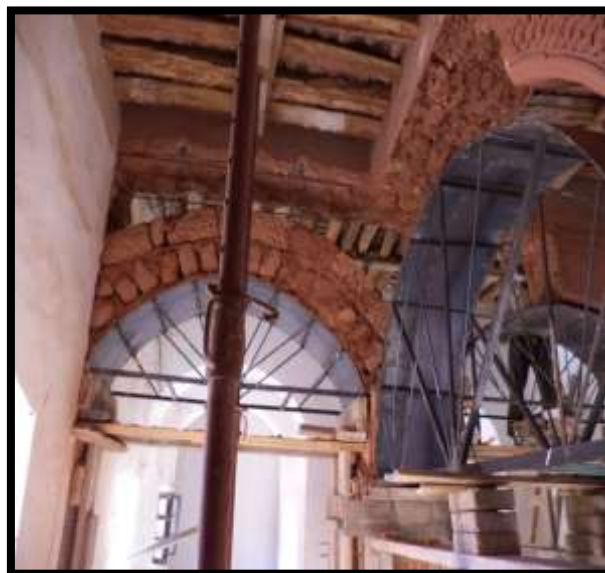
Figure 16: Image showing the restoration process of the arch support.
